# Heritage Impact Assessment

Proposed relocation of stone planter and installation of Historic Drinking Water Fountain within the gardens of Ayscoughfee Hall, Love Lane, Spalding, Lincolnshire

On behalf of South Holland District Council

A1572F – HIA rev P3

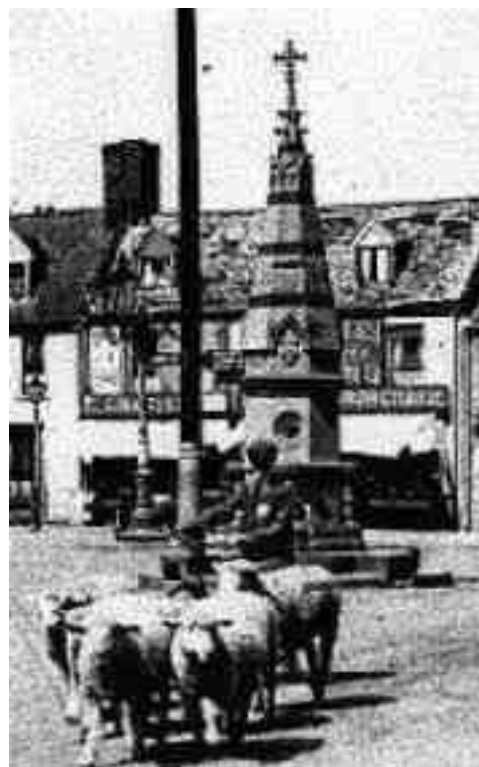
The 6metre (20ft) fountain is gothic in style and is made of sedimentary material (limestone or sandstone) with a granite plinth and is thought to weigh in the region of 78 tons. Through the centre of the fountain is an iron rod on which the parts of the fountain are assembled and this is topped with a metal cross. On alternate faces of the fountain are the Johnson family arms.

Image 1. Mary Ann Johnson drinking fountain

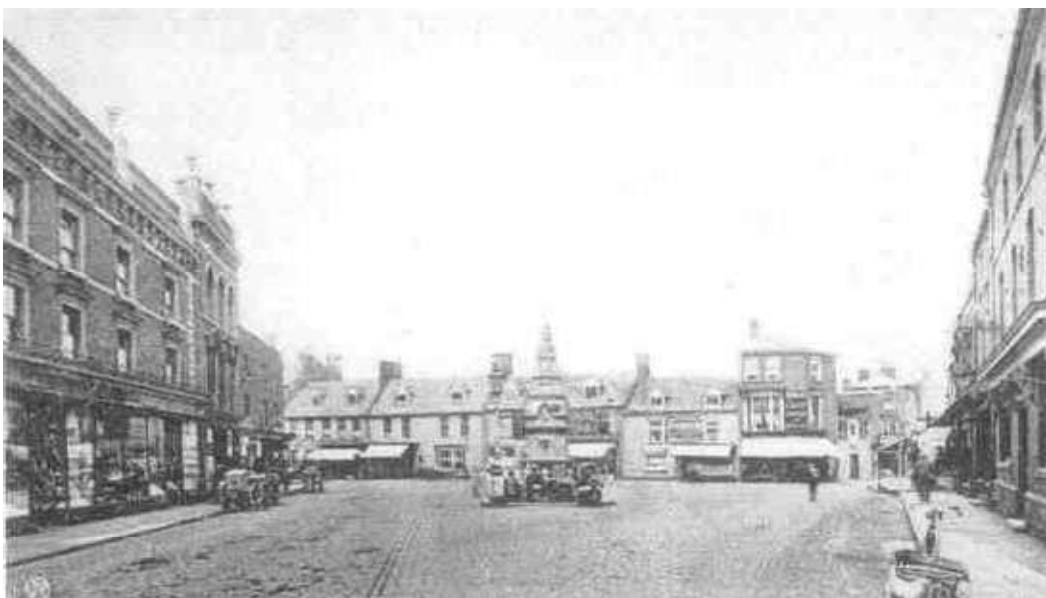
Image 3. (View 1) Hall Place early 1900's showing the Fountain with the northwest parade behind

19 Hall Place, which is the building to the left of the fountain (*Image3*) is the only one that is listed.

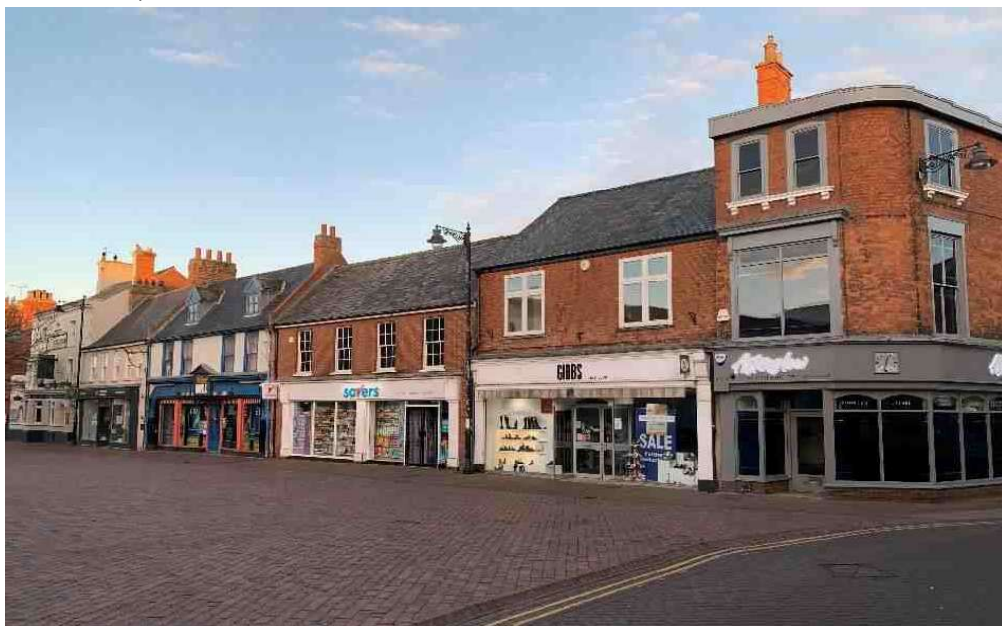
*Image 5 (View 4) northwest parade – Hall Place, February 2022*

Comparing Image 4 with Image 5, it can be seen that in addition to the road layout changes, the buildings on the northwest side of Hall Place have been extensively altered,

No. 20 Sheepmarket is the building to the far left of the group and is used as a public house. The roof has been altered. The dormer windows removed and it appears that another storey has been added.

No. 18 Hall Place, has a modern shop front and two dormer windows have been removed.

No. 19 Hall Place, Grade2 listed has a modern shop front and the windows have been replaced

No. 20/21 Hall Place was rebuilt after 1985

No. 22 Hall Place has been completely rebuilt

No. 23 Hall Place has a modern shopfront and the first floor fenestration has been changed. The slate pitched roof appears to have been removed and a deep fascia added.

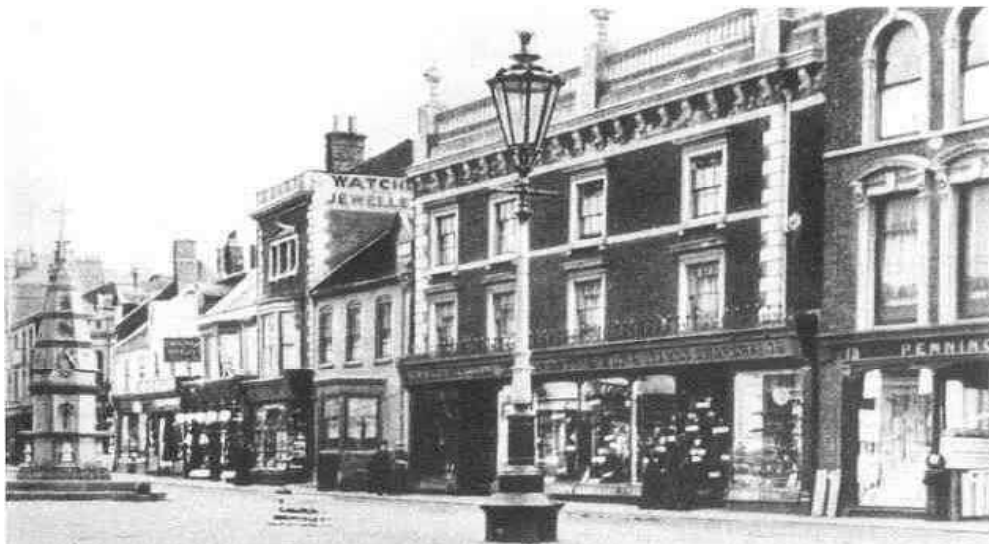
Image 6. (View 3) Hall Place early 1900's showing fountain and the southwest side of Hall Place

Comparing Image 6 with Image 7, it can be seen that the southwest side of Hall Place has been completely rebuilt. The decorated three storey building have been replaced with angular mainly two storey structures. The road layout has been changed with traffic original passing both sides of the fountain. It is thought that the fountain's relative position would now be near the tree and the lay-by (See Image 7 and Image 10).

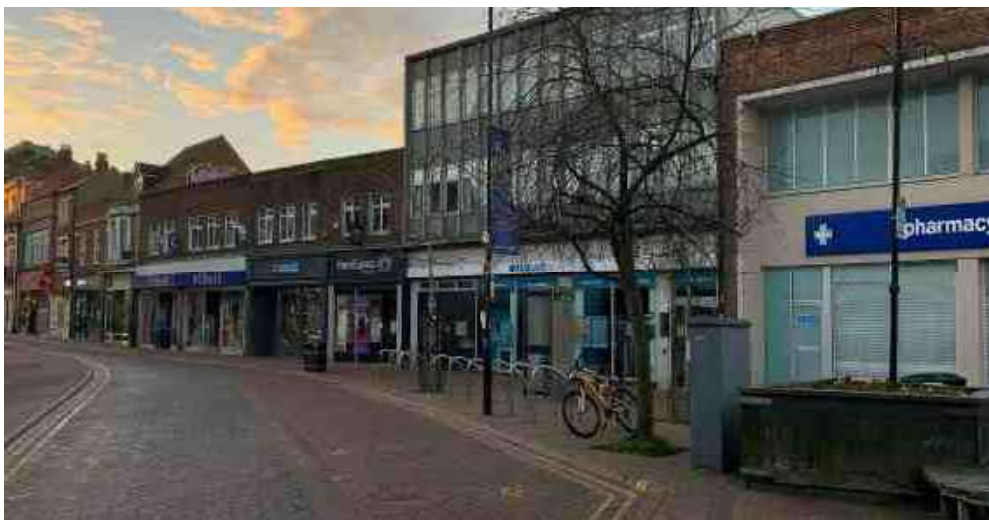
Image 7 (View3) Hall Place southwest side, February 2022 (Note: The photograph foreshortens the view, see Image 10)

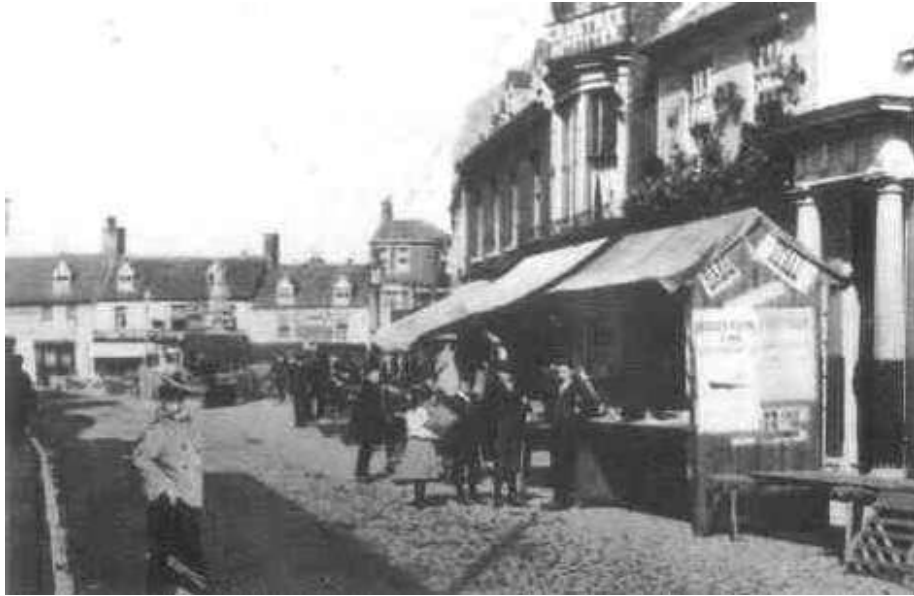
*Image 8. (View 2) Hall Place early 1900's showing fountain and the eastside of Hall Place*

Comparing Image 8 with Image 9, it can be seen that the road is much narrower in the modern photograph. While there have been new shopfronts installed and modern windows there are still some features remaining from the early 1900's photograph.

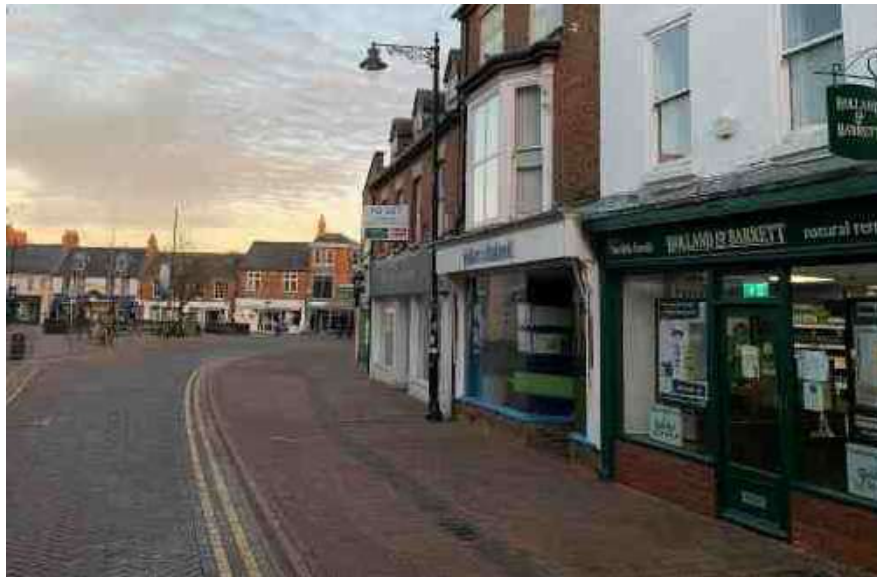
*Image 9 (View2) Hall Place east side, February 2022*

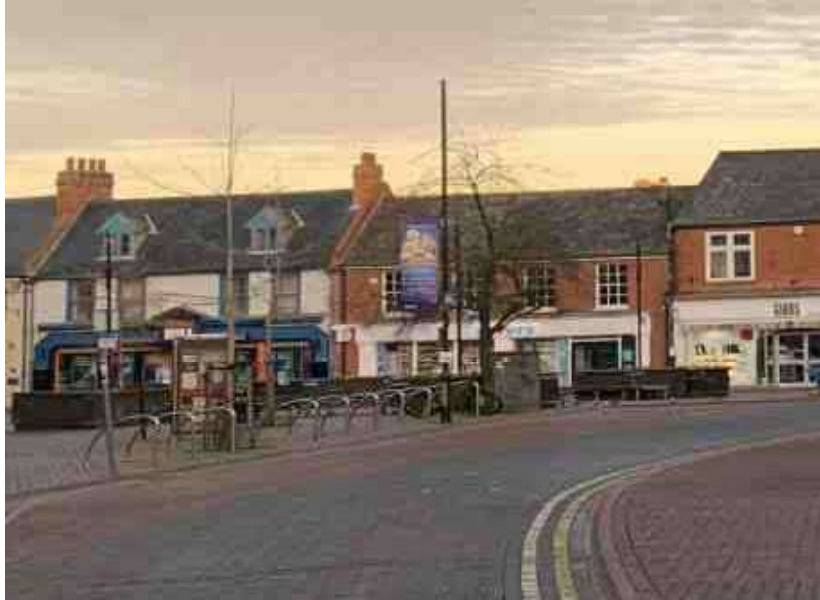
*Image 10 Detail from Image 9 (View2 )*

As previously discussed, it can be estimated that the original site of the fountain would now be close to the tree and the lay-by shown in Image 10 above (also shown in *Image 7*).

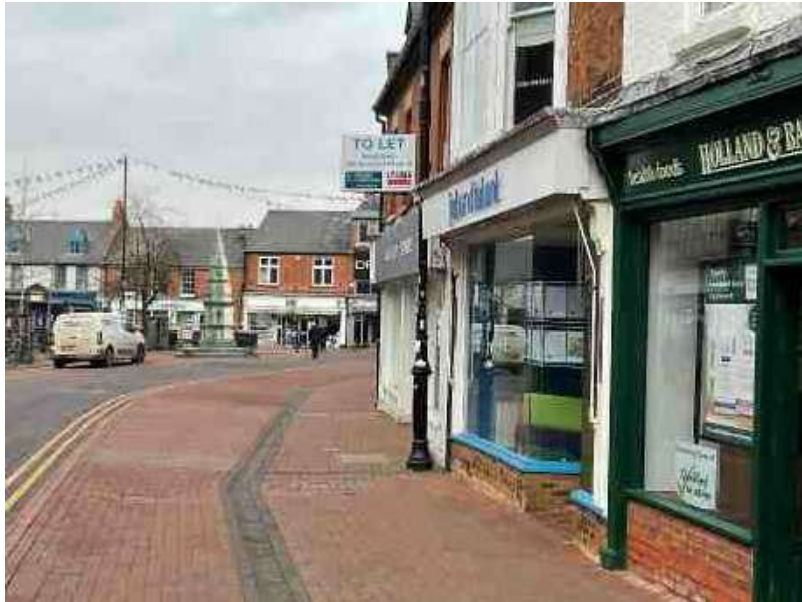
*Image 11 (View2 ) The fountain shown in its estimated original position in the new road layout*

It is difficult to be 100% accurate in assessing exactly where the fountain originally stood. Whilst the historic photographs give a good impression, the viewpoints and perspectives lead to some uncertainty into the exact centre point of the fountain. However, having studied various photographs, the estimated original position for the fountain would now appear an impractical proposition. The fountain would require suitable foundations and there is now infrastructure that would be very difficult to move to allow a foundation to be formed. Working to the original location we also believe that the fountain would sit very close to the road and the lay-by area would have to be changed. Siting the fountain in this location may dictate a change to the paving and kerbing layout which in itself may be problematic, doing so would also mean that the fountain would be relatively close to the carriageway.

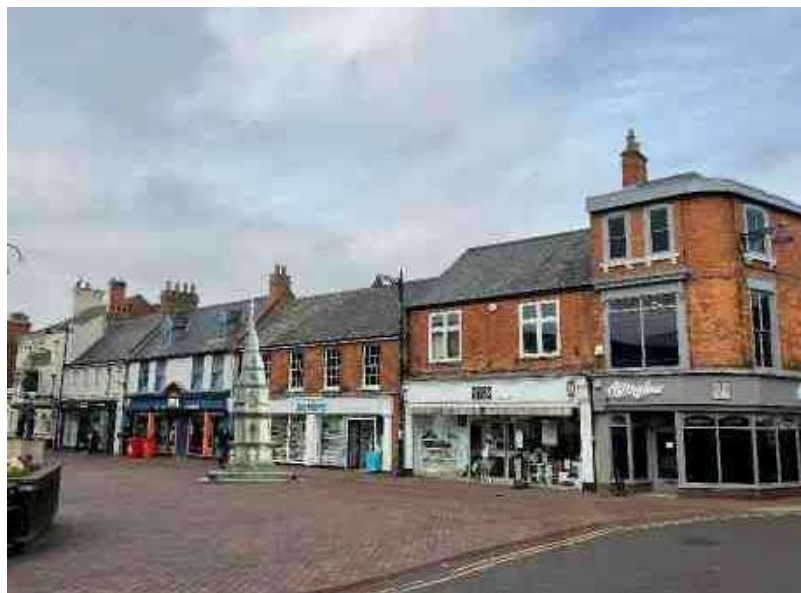
*Image 12 (View4 ) The fountain shown in a possible position in the northwest parade – Hall Place*

The fountain could be sited further towards the northwest parade of shops into the pedestrian precinct, but the parade does not give the backdrop that it originally did. The one listed building in the parade has been garishly painted and cannot be thought to give the fountain context, and one of the parade that was considered to be of local interest in the listing has since been demolished.

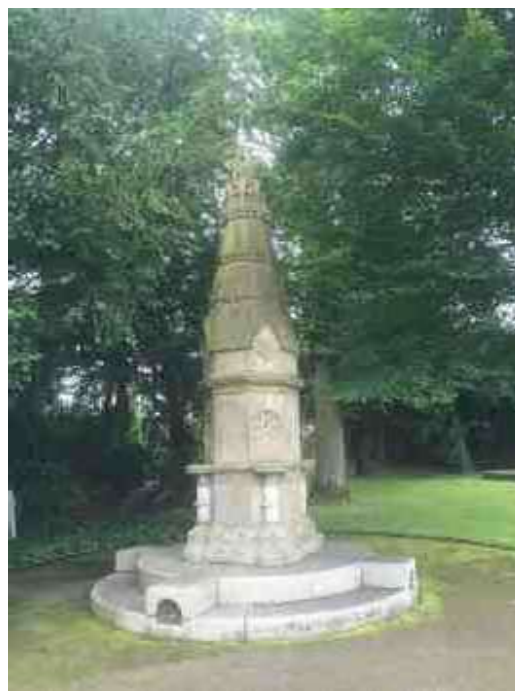
*Image 13. Photograph of the drinking fountain in Ayscoughtee Gardens, prior to removal in 2018*

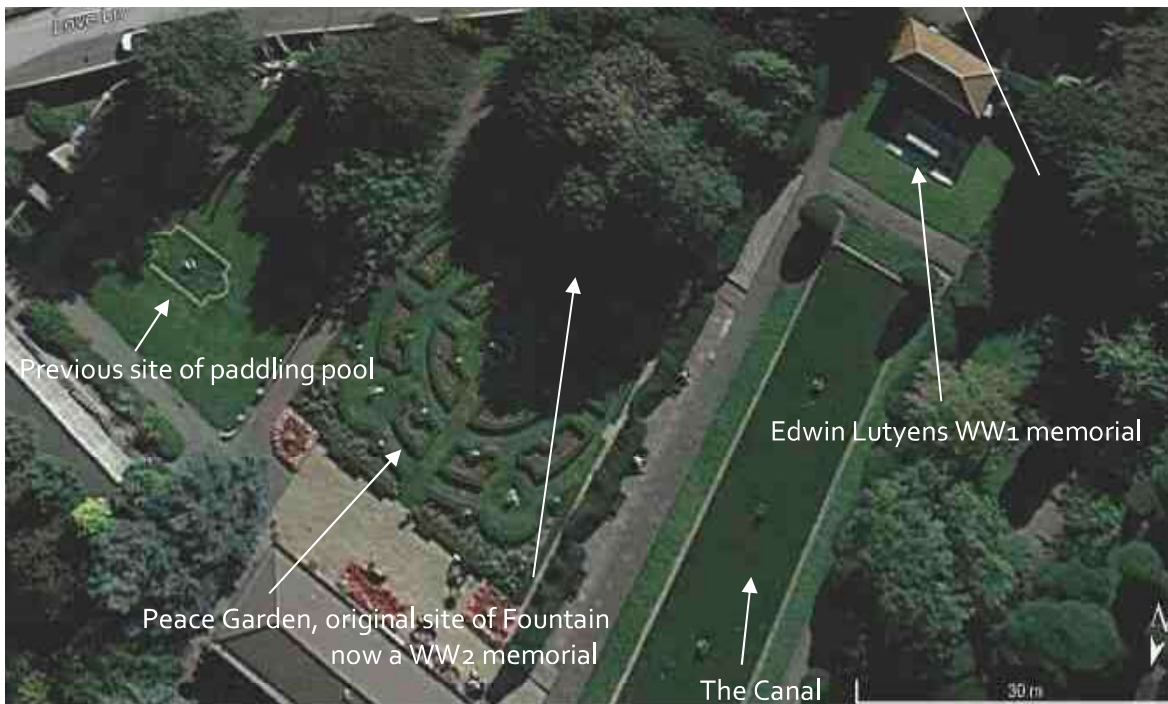
Image 16. Aerial View showing the relative positions of the features discussed in the document.

Dated after the removal of the fountain, the low level wall forming an entrance to the paddling pool has also been removed

South is approximately to the top of the photograph

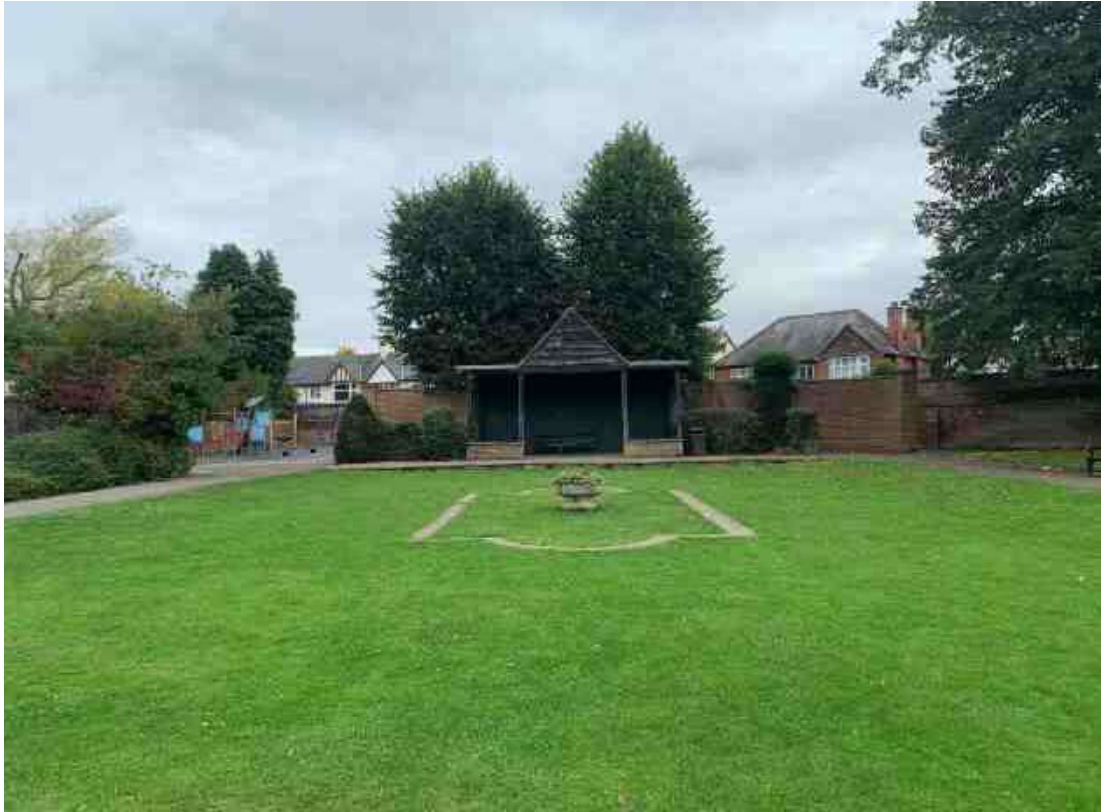
*Image 17. Photographs from the edge of the path toward the former paddling pool with its planter. The paddling pool was present in 2000 at the time of Anderson and Glenn's report, now there only remains the slabs which outline its shape. The centre of the pool is the proposed site No 3*

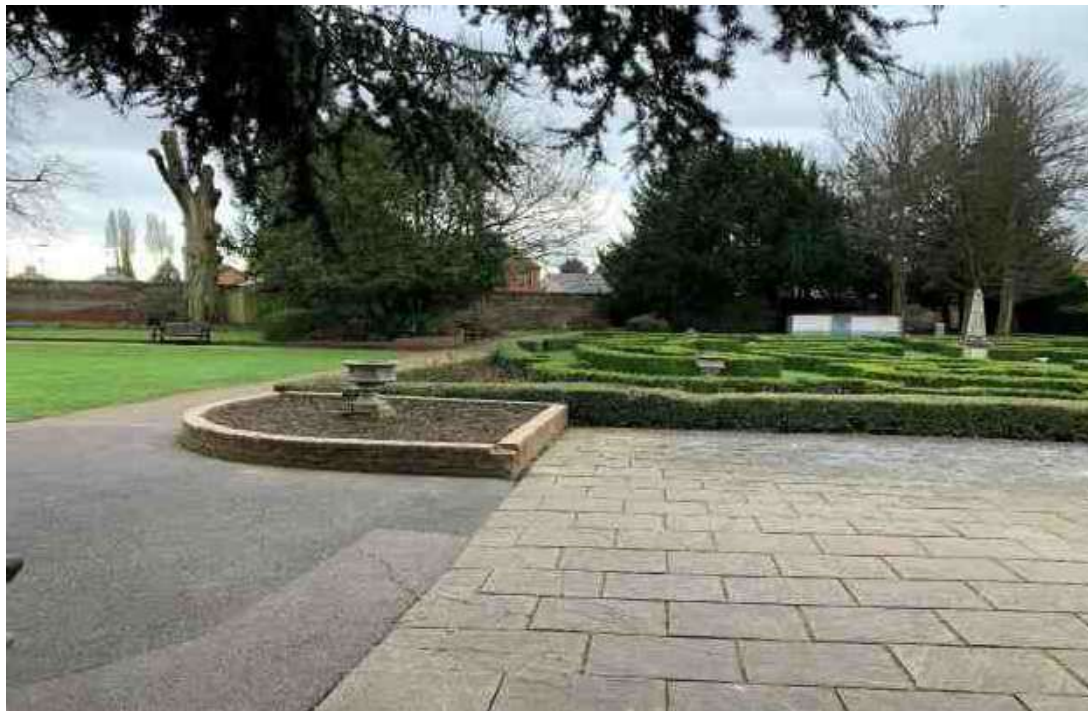
*Image 18. Ground view showing the relative position of the Peace Garden and proposed site 1, adjacent to the tarmac path to the left of the photograph and site 2, which would be to the left of the dead tree in the background of the photograph*

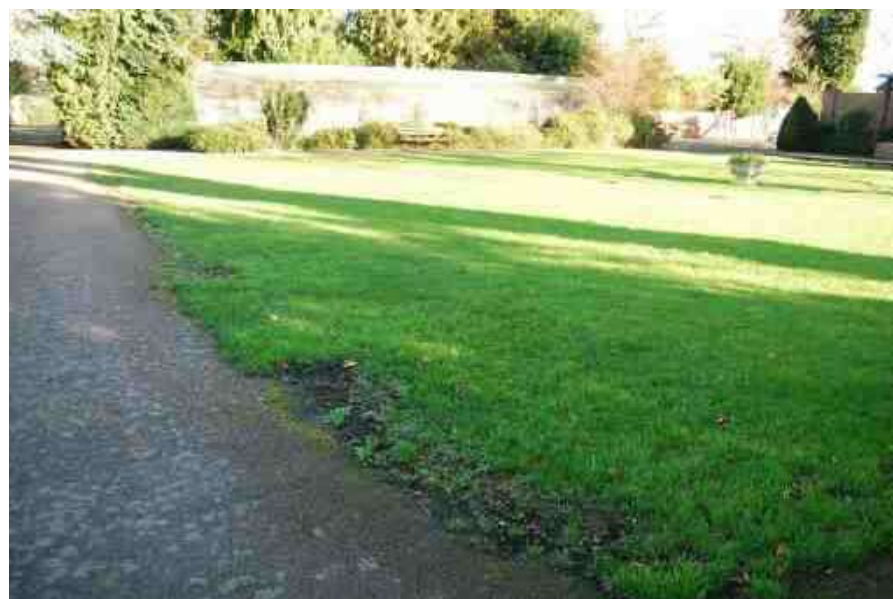
Image 20  
Proposed position 1  
at edge of tarmac  
path

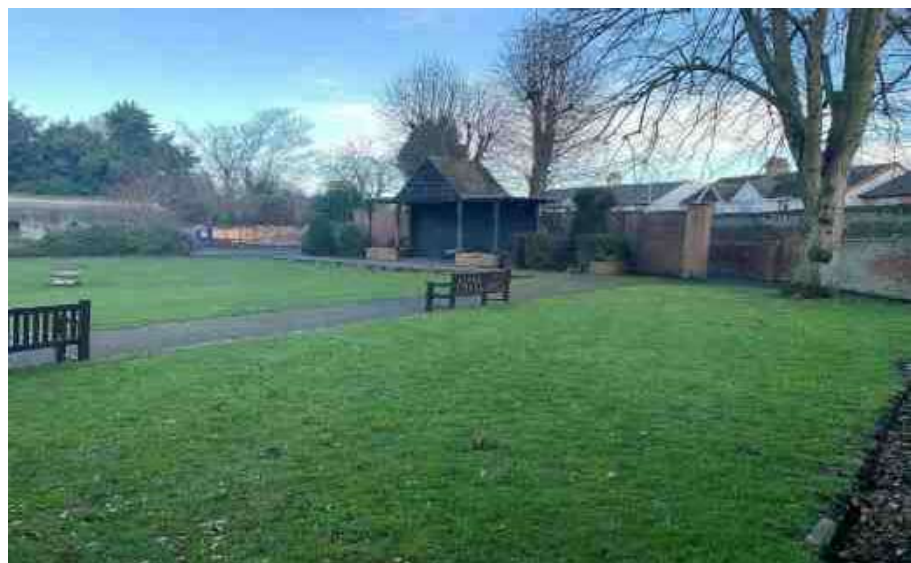
Image 22 - View from the proposed position 2 of the fountain at edge of the tree area towards the paddling pool

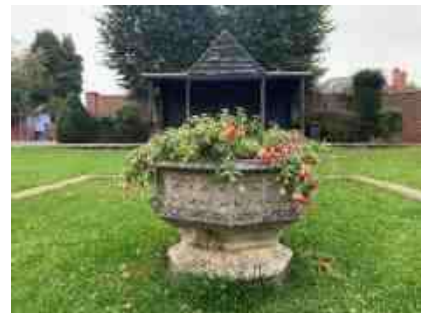
The origin of the planter that sits at the centre of the slabs had at one time sat in the centre of the pool when it had been drained. There are many similar planters around the gardens.

Image 24 The planter that is to be moved (Drawing A1572 provided in the Appendices shows a possible relocation)

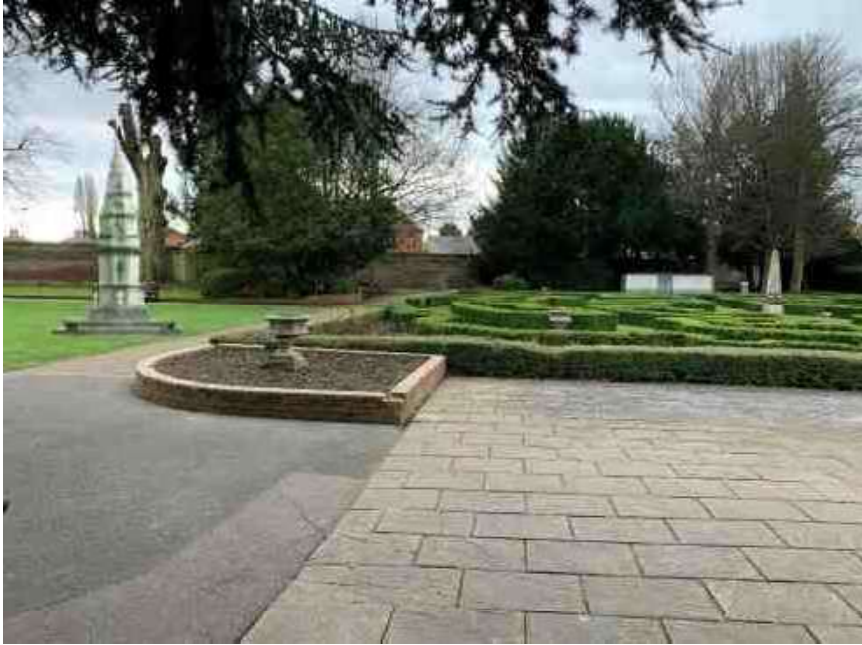
*Image 25 The fountain shown in position close to the peace garden as seen from the cafeteria*

- 7.1.1 This position, while giving a good view of the fountain from close to the cafeteria area, it dominates the area. At 6metres tall the fountain is more than twice the height of the obelisks within the garden, this can be seen from images 25 &26. Because of this it takes the eye away from the smaller obelisks and the memorial plaques that are at ground level.

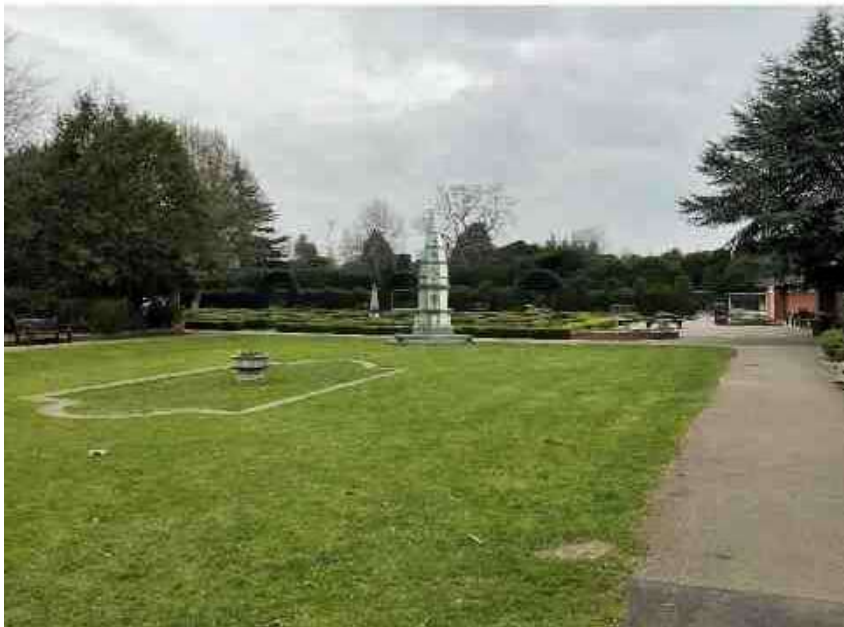
*Image 26 The fountain shown in position close to the peace garden as seen from the bandstand*

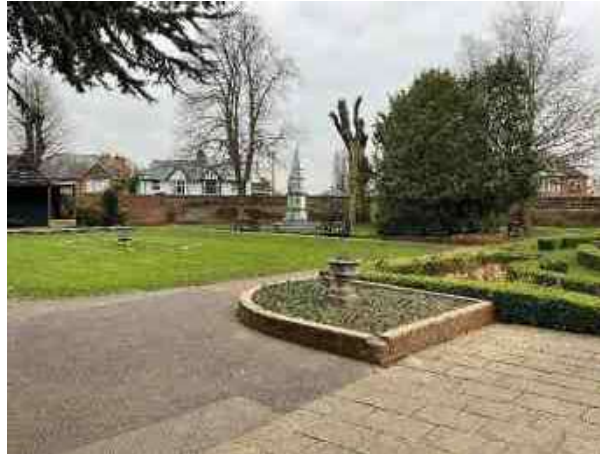
*Image 27 The fountain shown in position as seen from the cafeteria and the peace garden*

7.2.1 This position provides the fountain with its own area but it is not in an area which has a great deal of use. It is also only viewable from one side with the seats facing away from it.

7.2.2 Close to vegetation the fountain will be quite vulnerable to moss and lichens growth, these are both more than a cosmetic problem, moss in particular penetrates the stone and they both hold moisture against the stone which will cause frost damage.

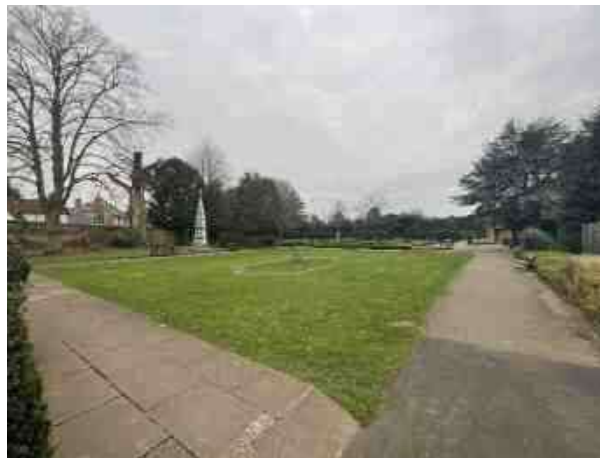
*Image 28 The fountain shown in position as seen from the bandstand*

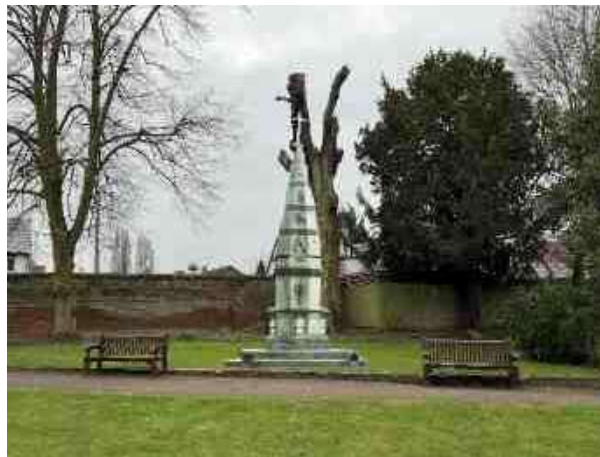
*Image 29 The fountain shown in position as seen from the paddling pool area*

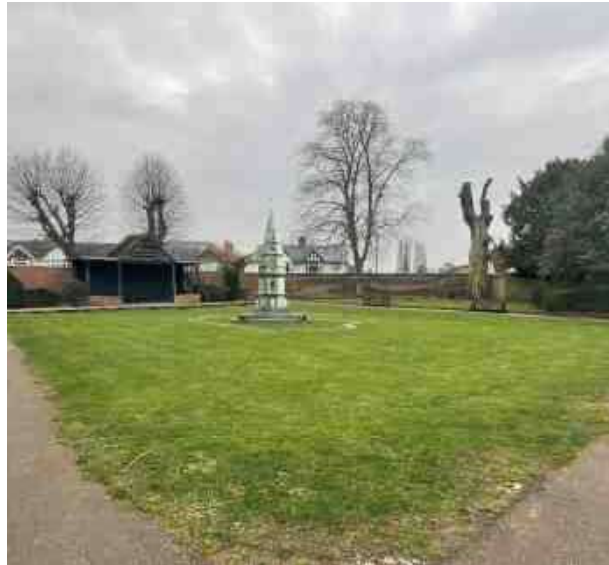
*Image 30 The fountain shown in position  
In the centre of the slabs outlining the  
previously removed paddling pool, viewed  
from the cafeteria*

7.3.1 This position provides the Mary Ann Johnson fountain with a prominent position

- 8.8 In contrast to the other positions, in position 3, at the centre of the former pool, the fountain does not overshadow the peace garden and stands in its own right. It can become a focal point in an empty area and could both be educational and allow for picnics or a new seating arrangement for families.
- 8.9 The new position for the Mary Ann Johnson drinking fountain has been informed by historical research and repositions it within an historic context. Its new position is intended to be sympathetic to the existing gardens and structures while ensuring that it is not vulnerable to damage or vandalism.

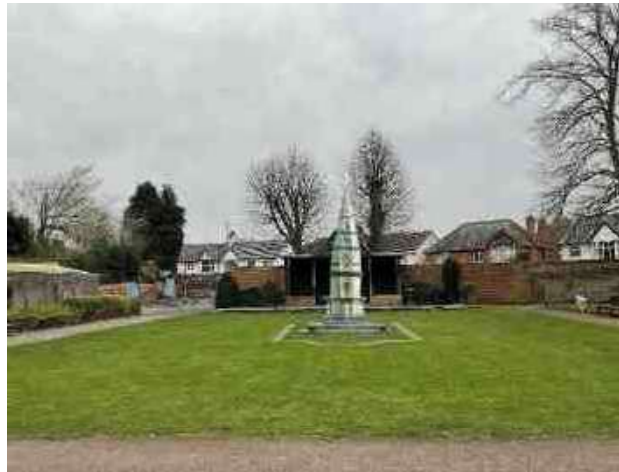
*Image 31 The fountain shown in position  
as seen from the peace garden*

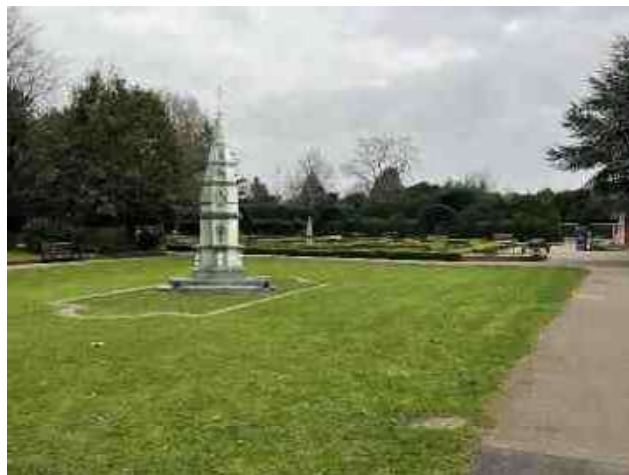
*Image 32 The fountain shown in position  
as seen from the bandstand*

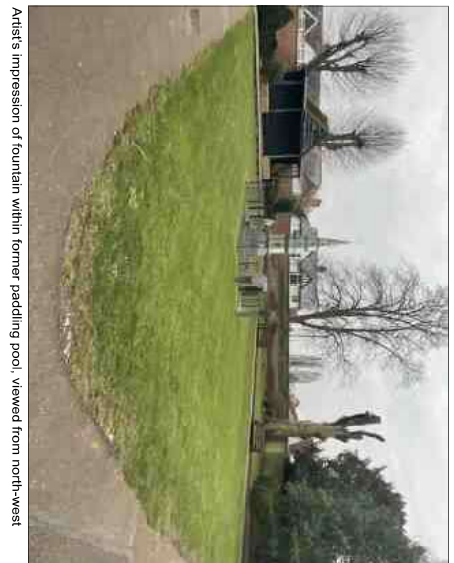
Artist's impression of fountain within former paddling pool, viewed from north-west
